Report Number	BCSR - 0001	Date of Issue	28th September 2016
Scope of this Work	Static test on strain clamps. Static and destruction test suspension clamps.	Client Contact	Phillip Hogg TranNet LTD PO Box 39383 Howick Auckland New Zealand
Location at which the work was conducted	Cookes Rigging Loft Auckland	Application	Strain and suspension clamps on 35mm <sup>2</sup> and 95mm <sup>2</sup> cables

Summary of static load test on suspension clamp

### Tension Testing Report

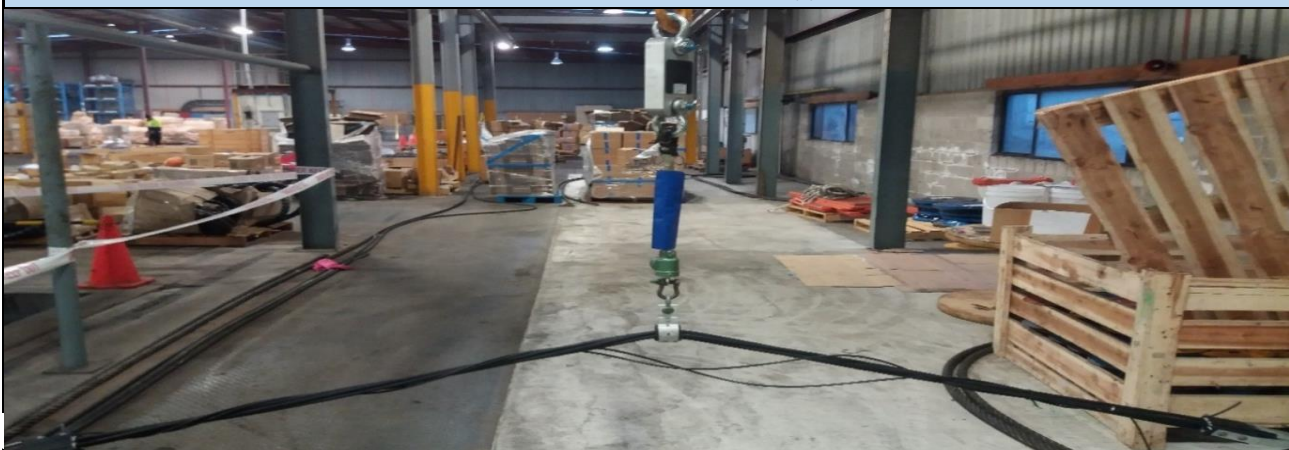
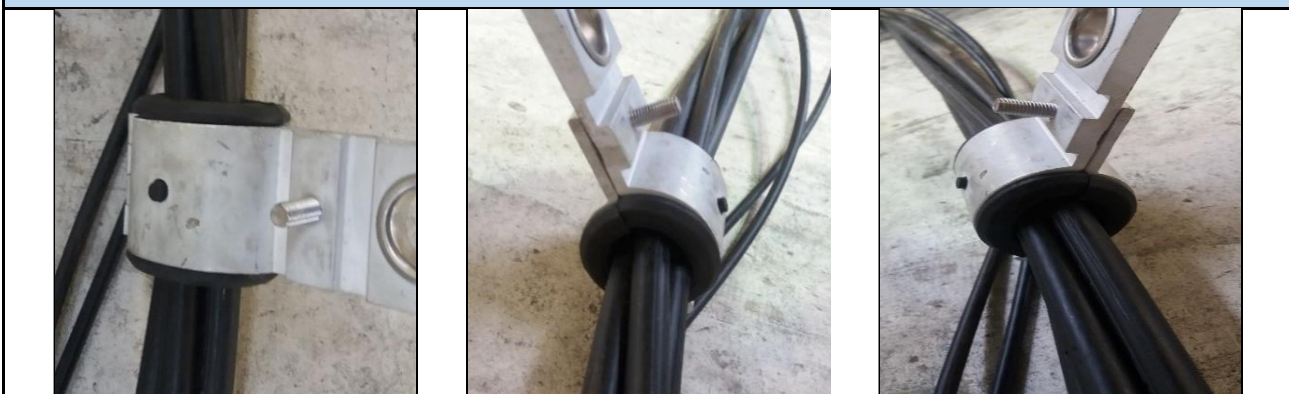
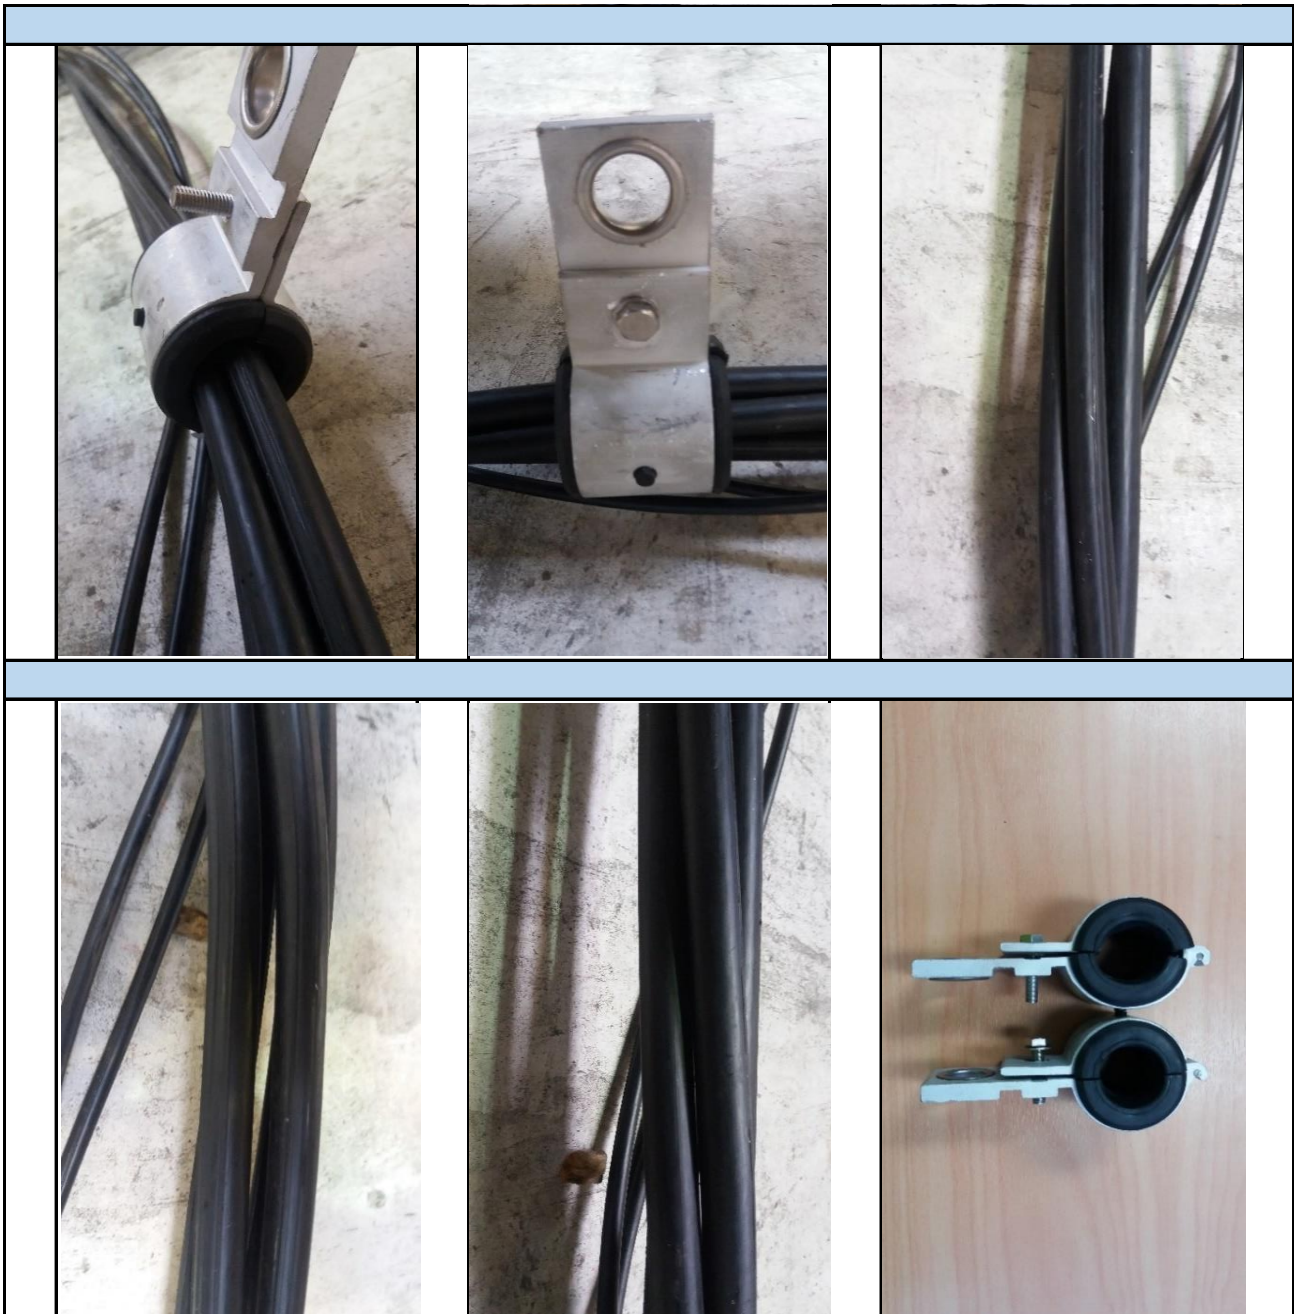
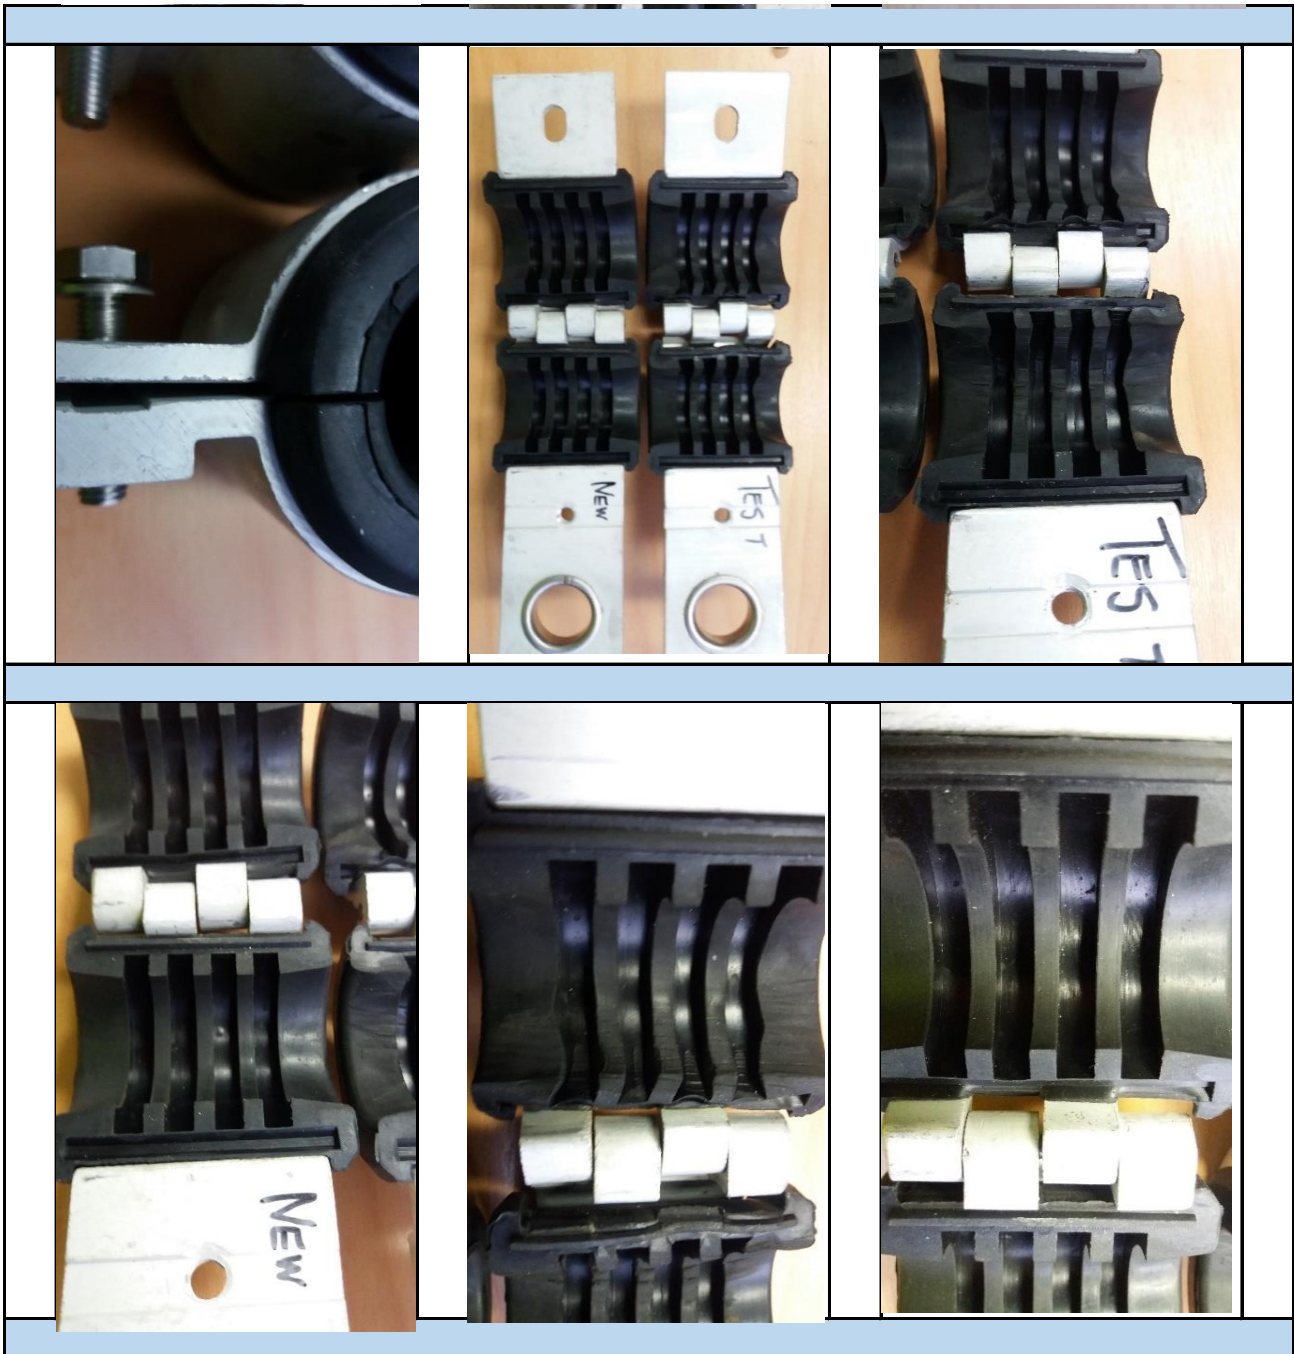
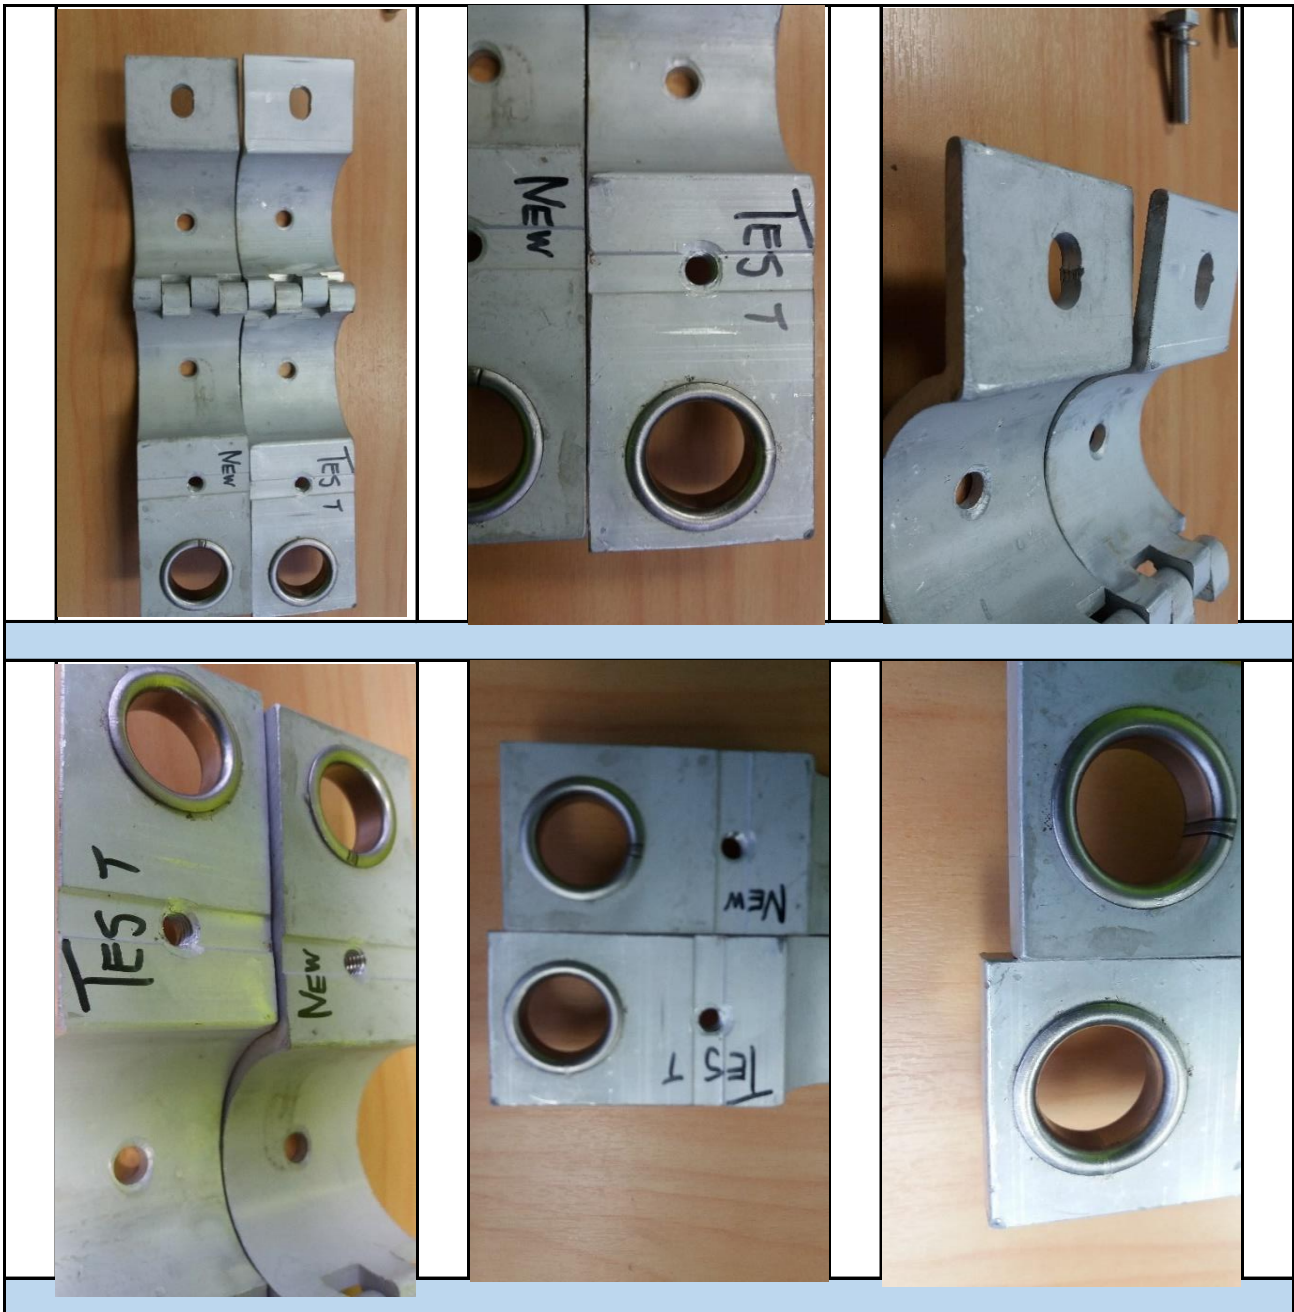
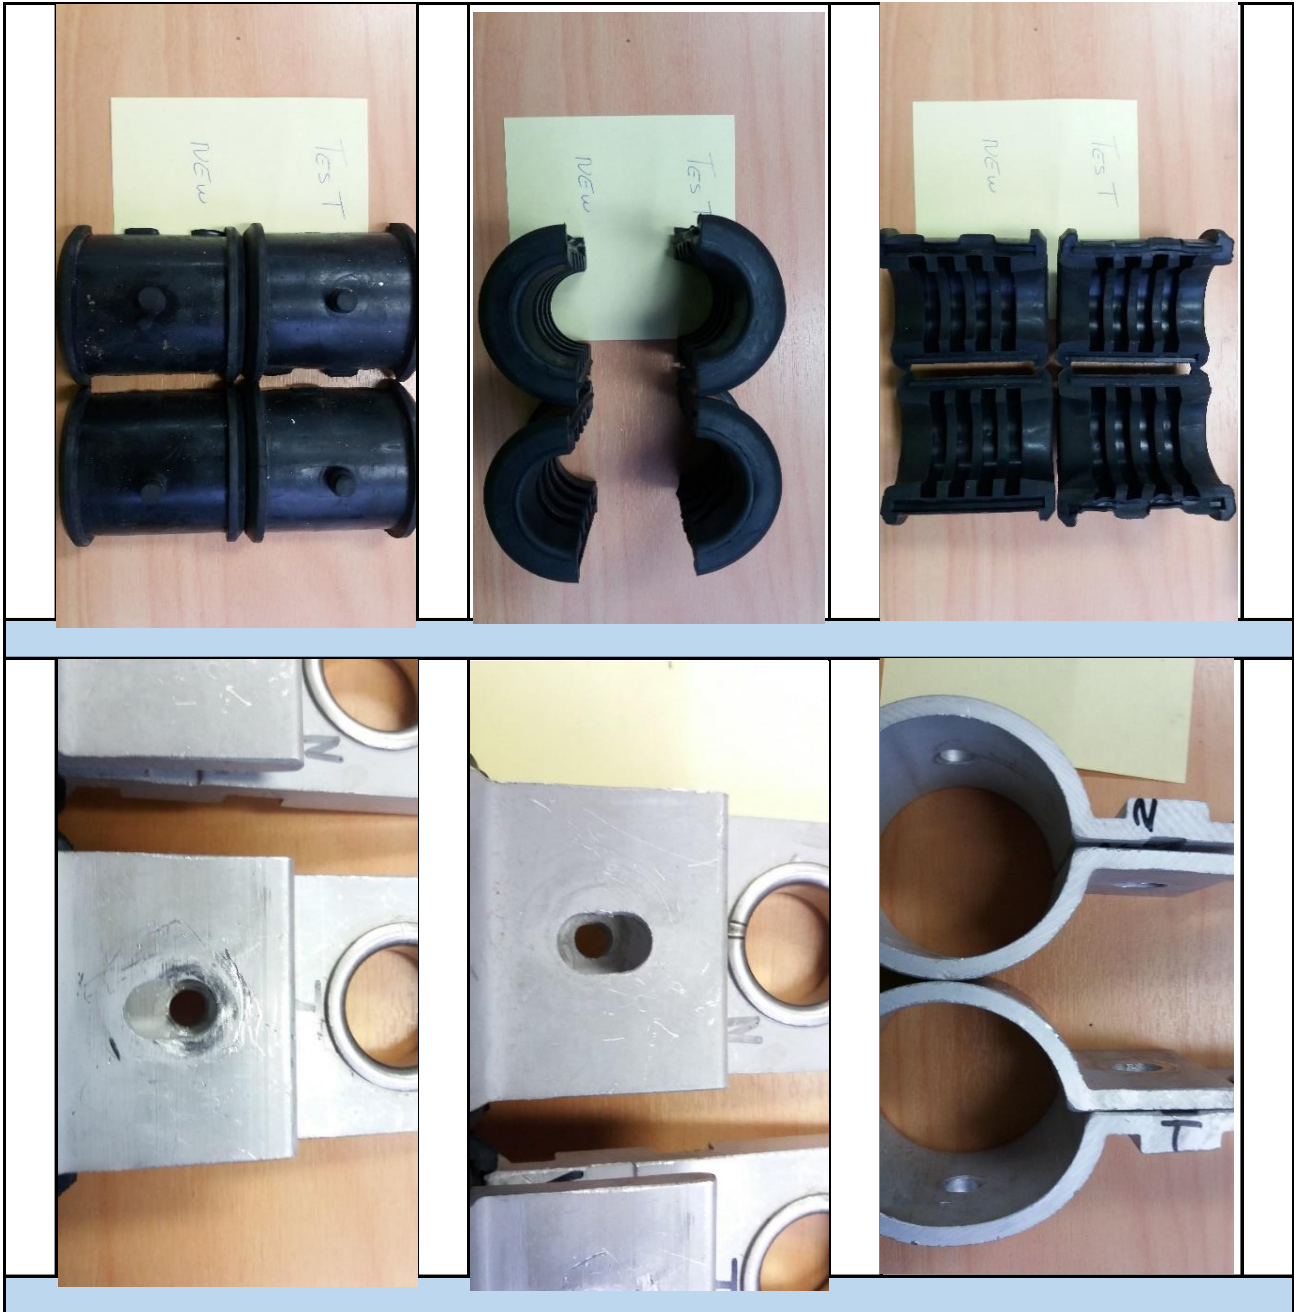
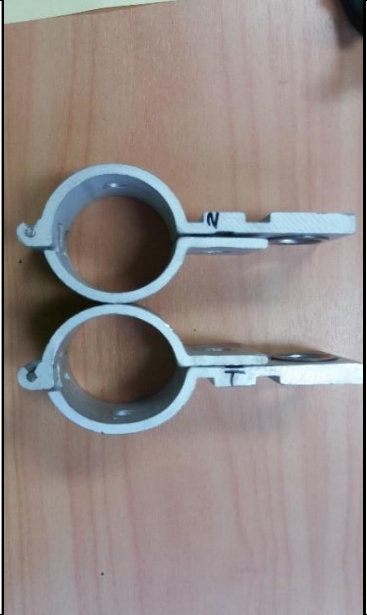
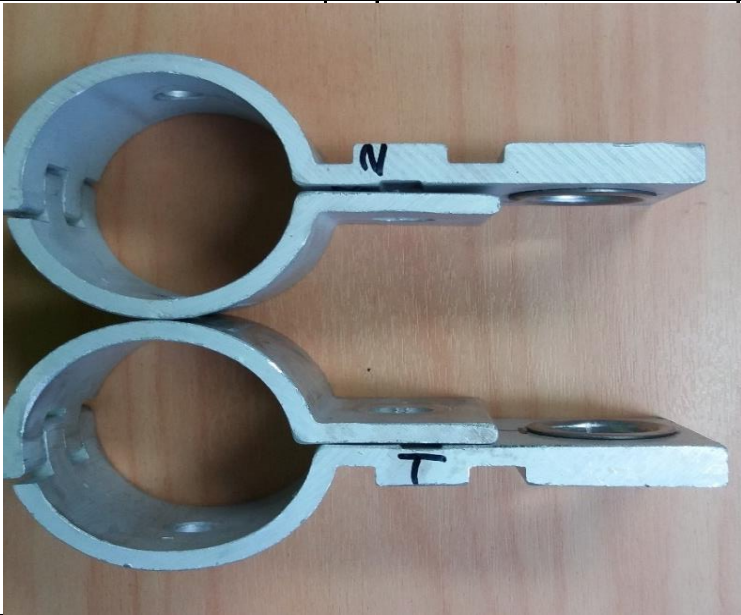
Additional Information / Picture(s)

The test Clamp was compared with a new clamp and photos take showing the deformation of the test unit see below photos

<b>Conclusion</b>	
Deformation was noted on the insulation and on the clamp as seen in attached photos. The clamp was still able to assembled and disassembled in a normal manner

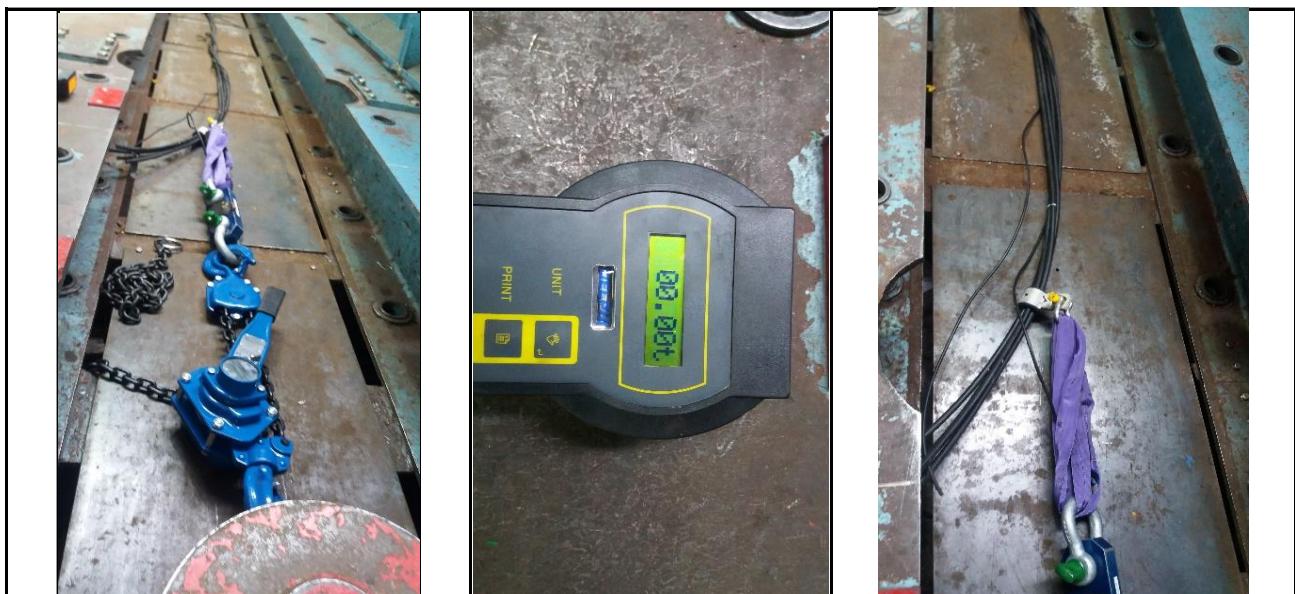
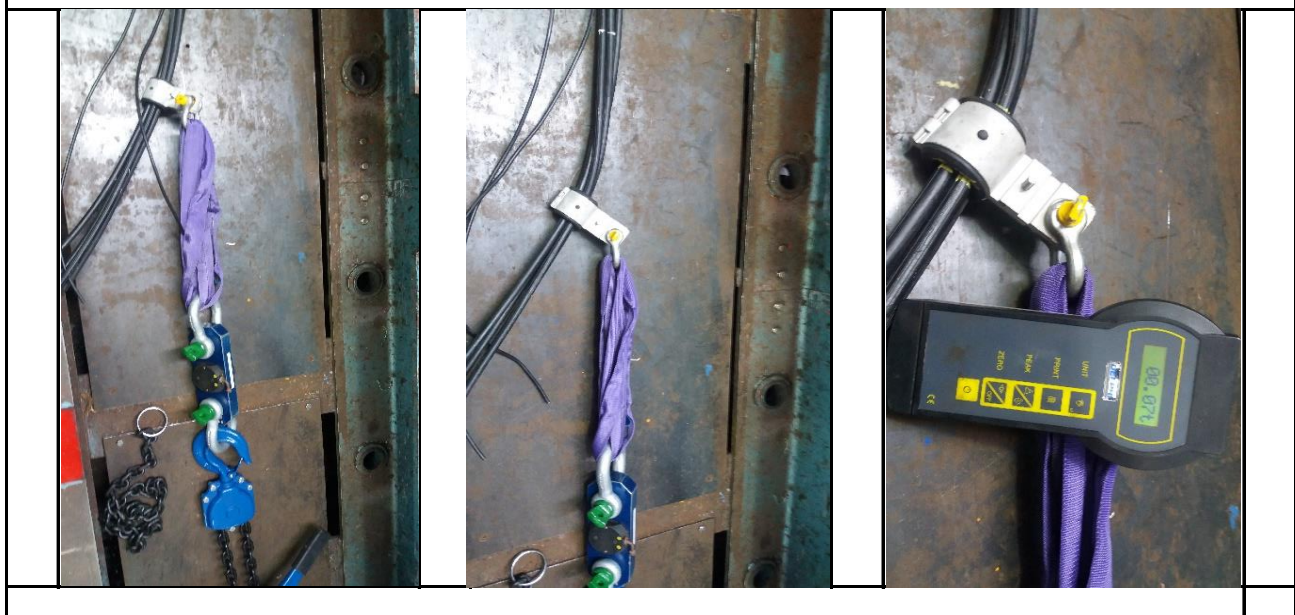
Summary of slip test on suspension clamp
Cookes Services carried out static load test on customer supplied suspension clamp with 95mm <sup>2</sup> cable as per AS 3766 - 1990.
Approach
The test assembly was prepared as Fig 4.2 and section 4.5.11. The load was applied as per Table 4.1 section 4. The bolt was torqued to 21.4 Nm.
Summary of Findings
There was no slippage noted or measured on the low test load. On the 2nd test the high load slippage was noted from 240kg's down to 210kg's where it seemed to settle down.
Additional Information / Picture(s) Low load test

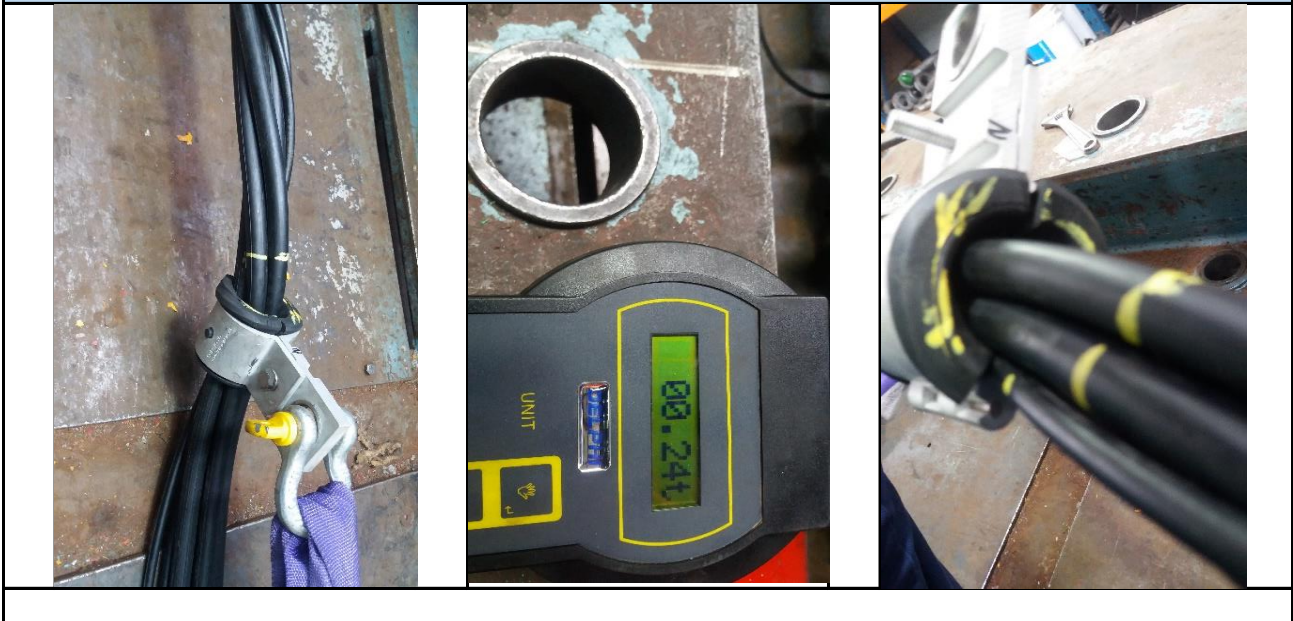
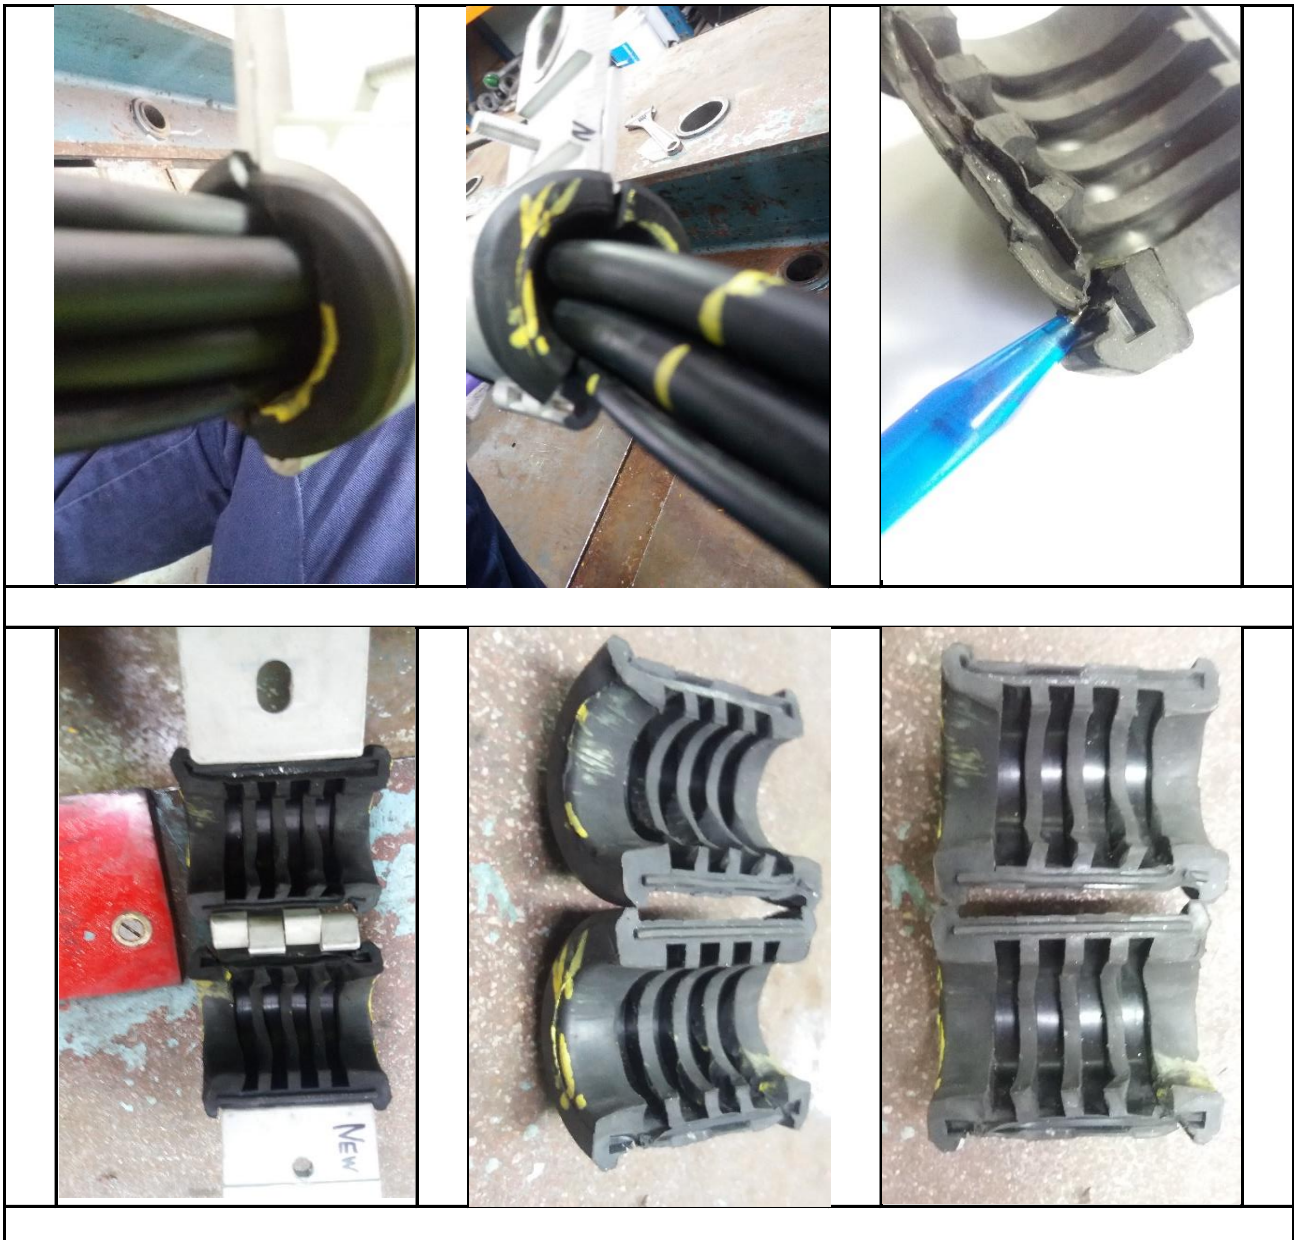
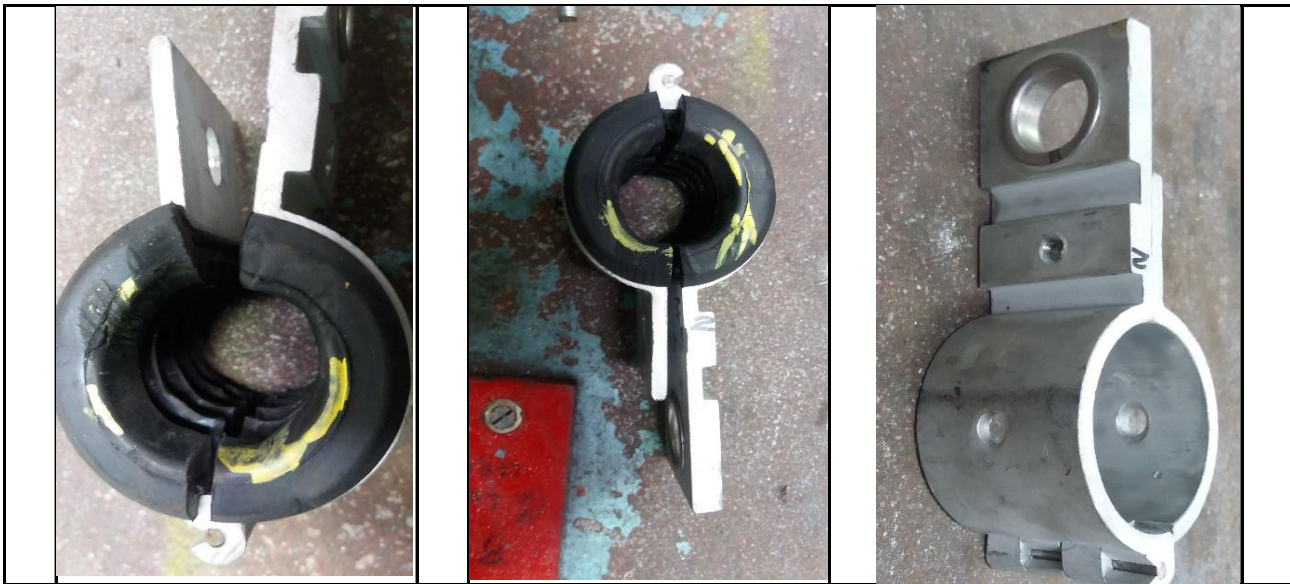
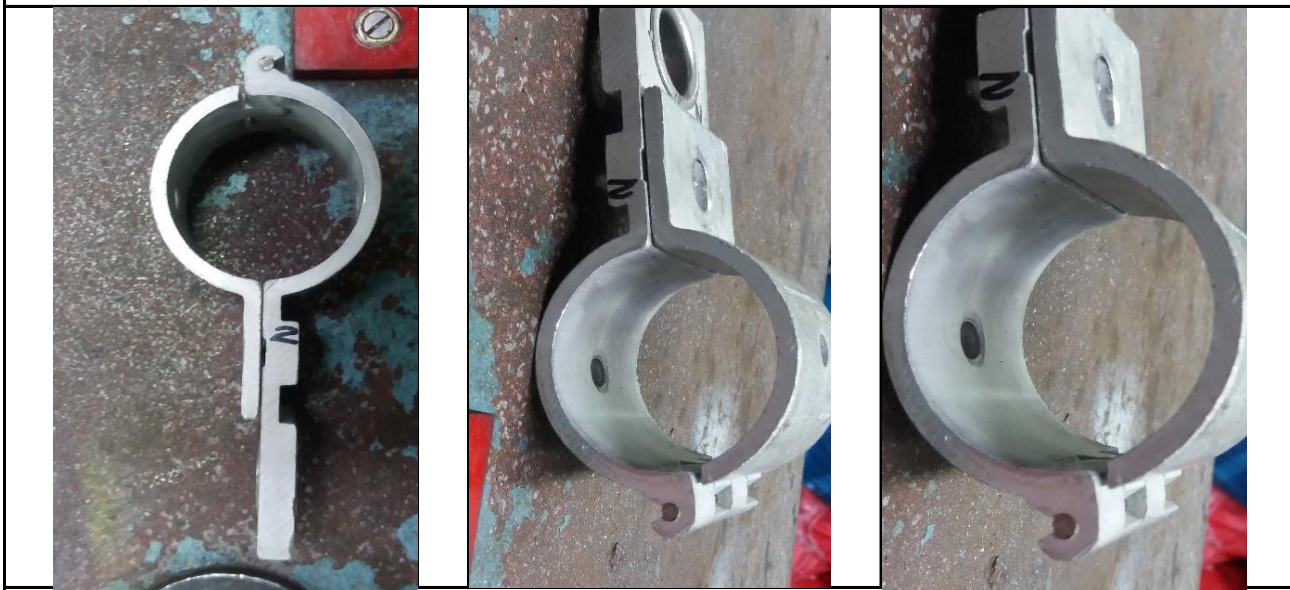
Additional Information / Picture(s) High load test

<b>Conclusion</b>
Deformation was noted on the insulation and on the clamp as seen in attached photos. The clamp was still able to assembled and disassembled in a normal manner
<b>Summary of load failing test on suspension clamp</b>
Cookes Services carried out static load test on customer supplied suspension clamp with 95mm <sup>2</sup> cable as per AS 3766 - 1990.
<b>Approach</b>
The test assembly was prepared as Fig 4.3 and section 4.5.13. The load was applied as per Table 4.1 section 4. The bolt was torqued to 21.4 Nm.
<b>Summary of Findings</b>
the load was slowly applied until the clamp failed see attached graph and photos
<b>Additional Information / Picture(s) Low load test</b>

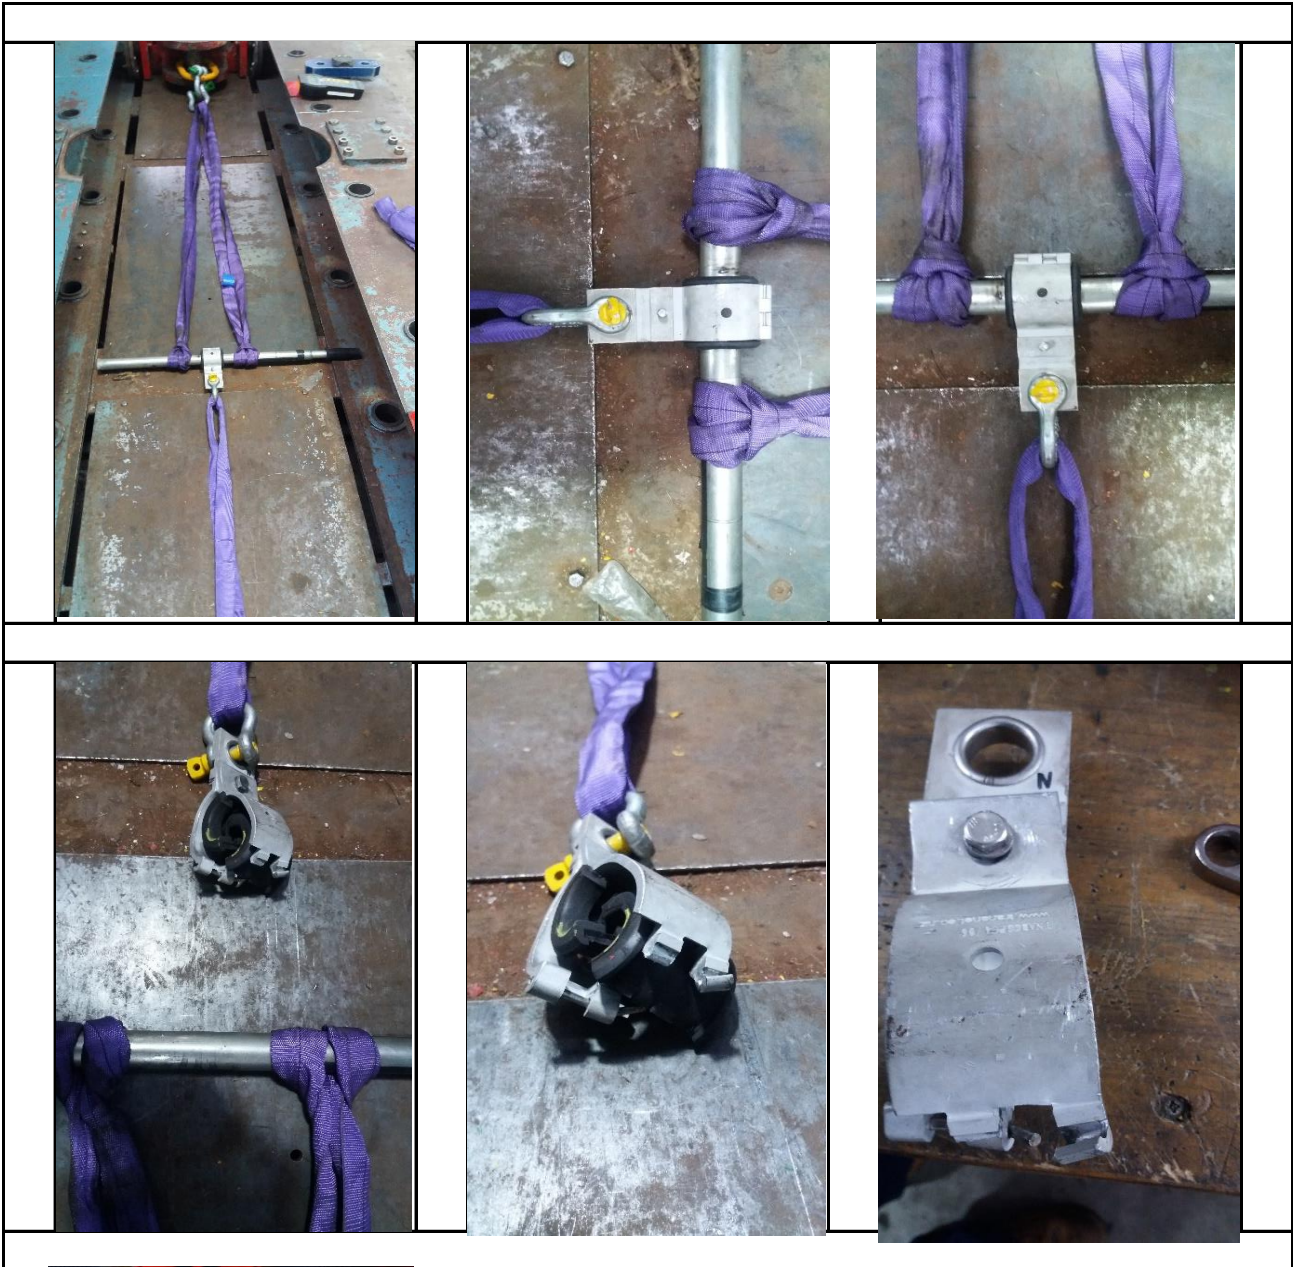
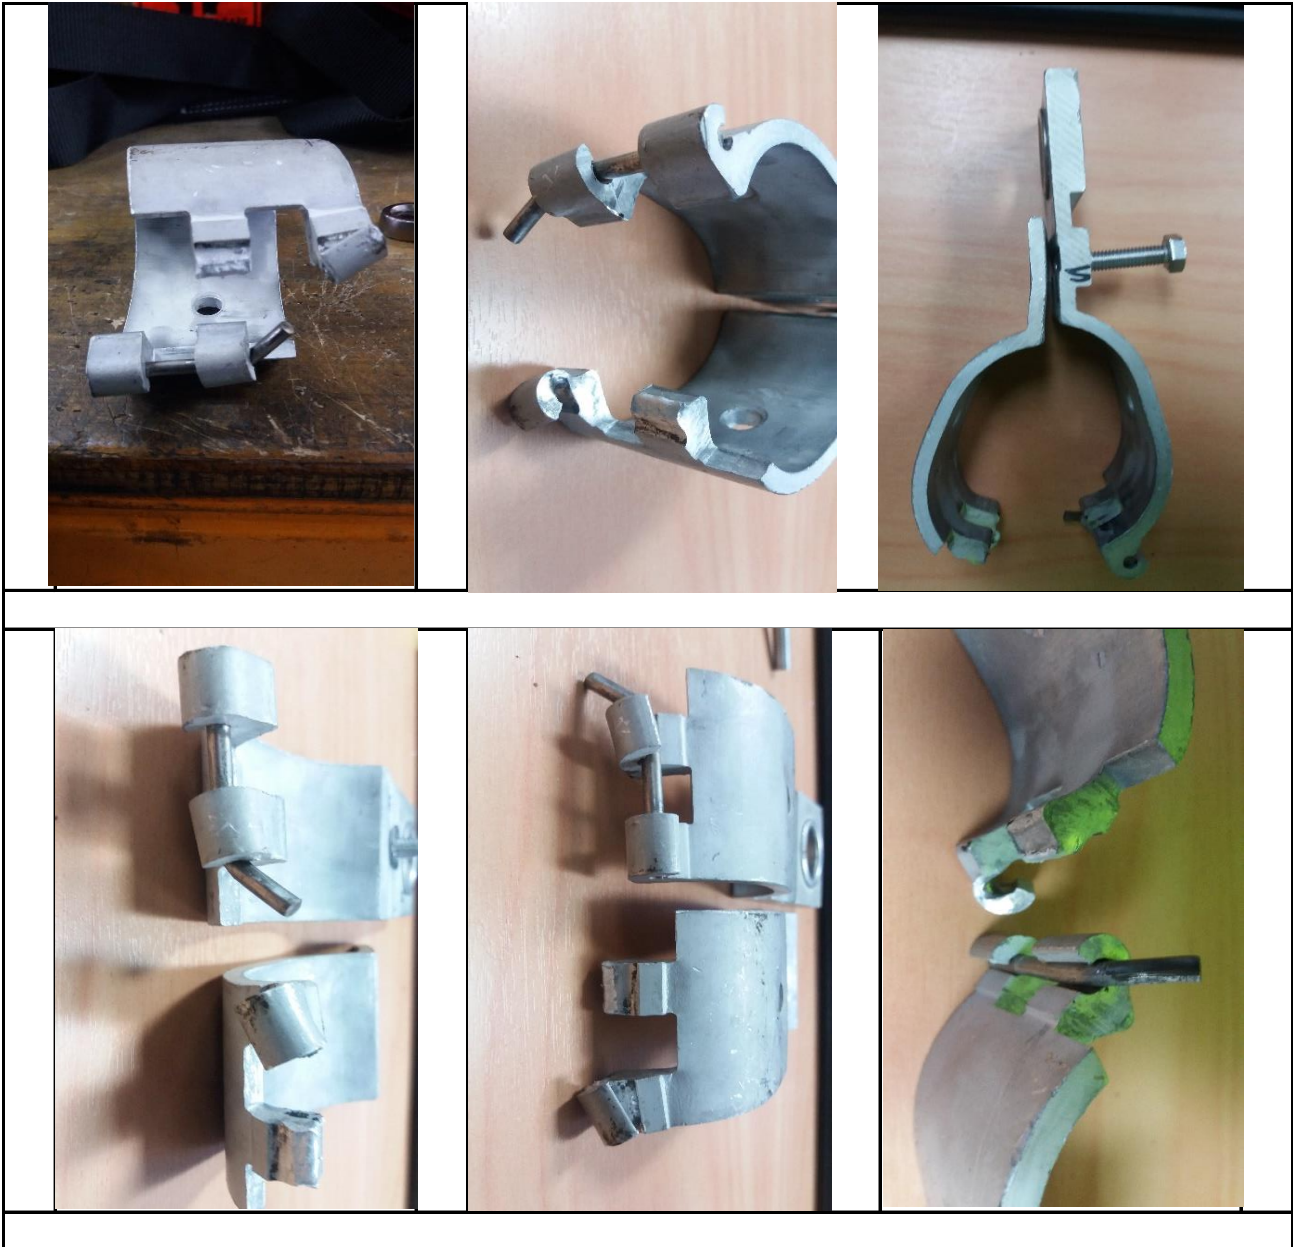
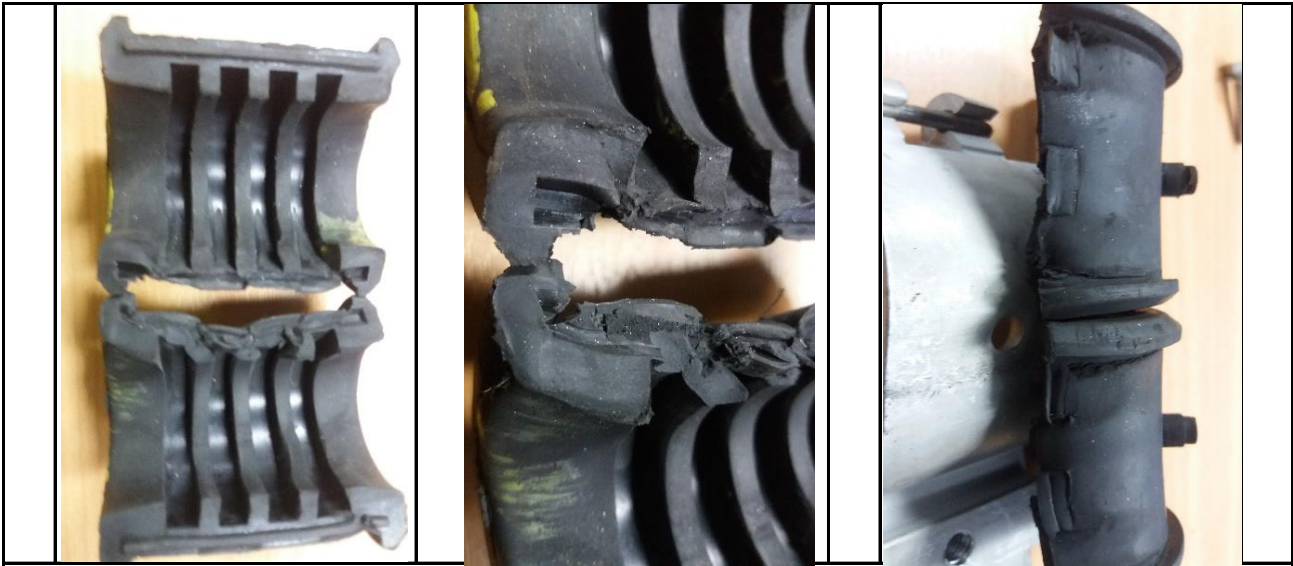
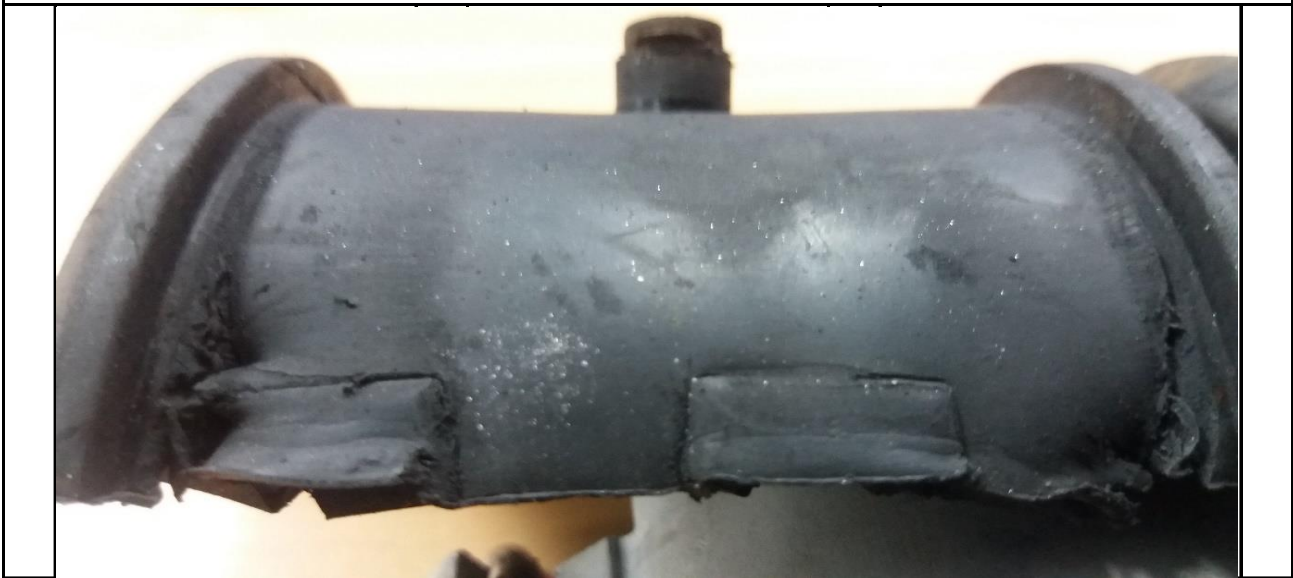
The clamp destructed on the hinge as seen in attached photos and deformation was noted on the insulation

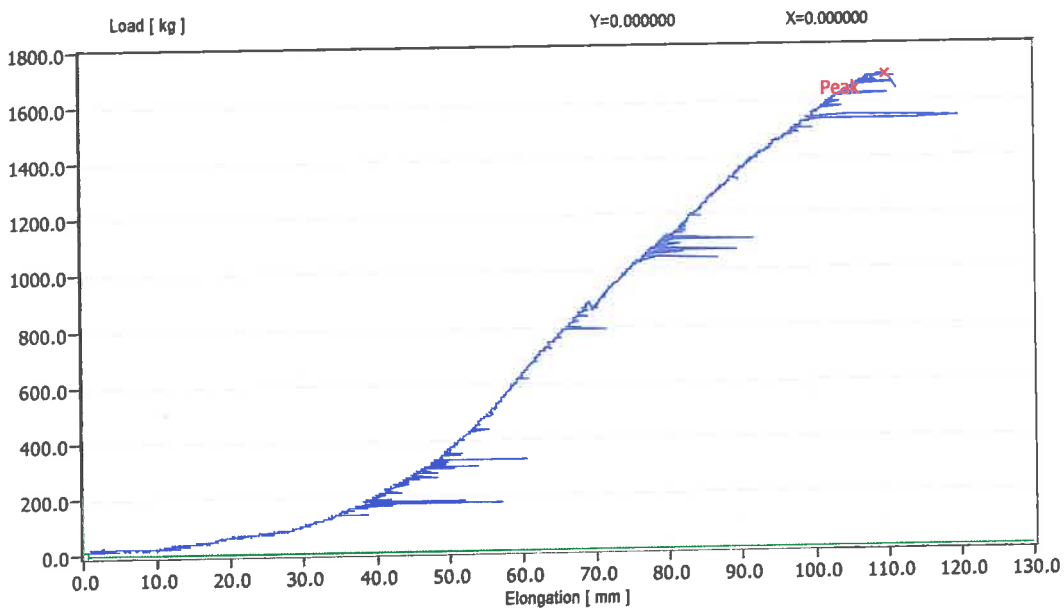
1.Certificate No. : TNABC SC4-95 - 95MM @ SUSPENSION CLAMP DESTRUCTION 1  
2.Customer : TRANSNET  
3.Operator : JAN JACOBS  
4.Date : 9/28/2016  
5.Time : 12 PM  
6.Temperature:  
7.Speed :20.00  
8.Test Style : Break Test  
9.Standard : AS3766  
10.Specimen : TNABC SC4/95 -95MM SUSPENSION 1 CLAMP DESTRUCTION  
11.Spec.Length: 3.00 m  
12.Notice :  
13.FileName : C:\Documents and Settings\Administrator\My Documents\Test Certs\SEPTEMBER 2016\@test-2.tst

Item	Load(kg)	Elongation(mm)
Peak	1694.9	110.02
