Job No.1-LA105.17
File Ref: AL1734/1
Page 1 of 4

Recycled plastic safety cover for open holes – Load testing.

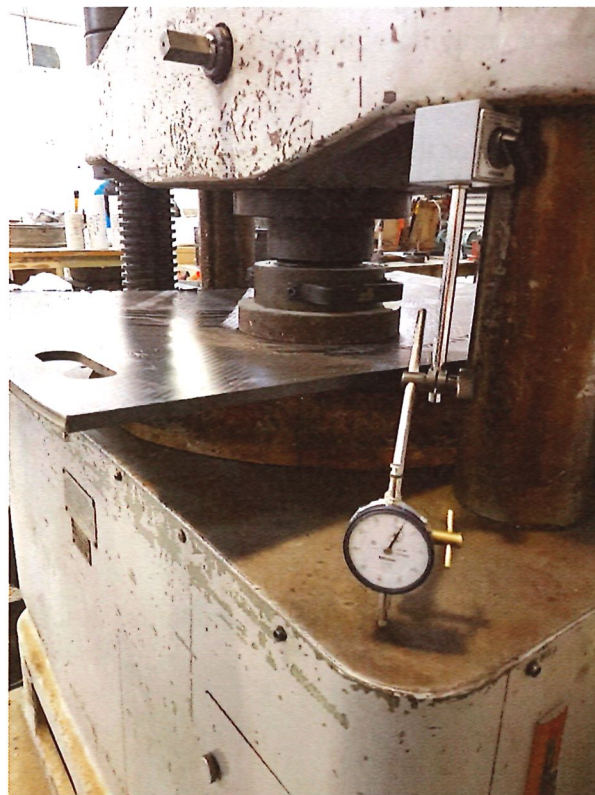
Figure 1 1kN load applied

| Applied Load (kN) | Applied Load (kg) | Figure number for photo at load (refer to pages 2-4) | Deformation at Centre (mm) | Observations |
|---|---|--|---|--|
| 0 | 0 | - | 0 | Increasing deformation as load increases. Refer to figures 1-3. No Failure observed. |
| 1 | 102 | 1 | 7.12 | |

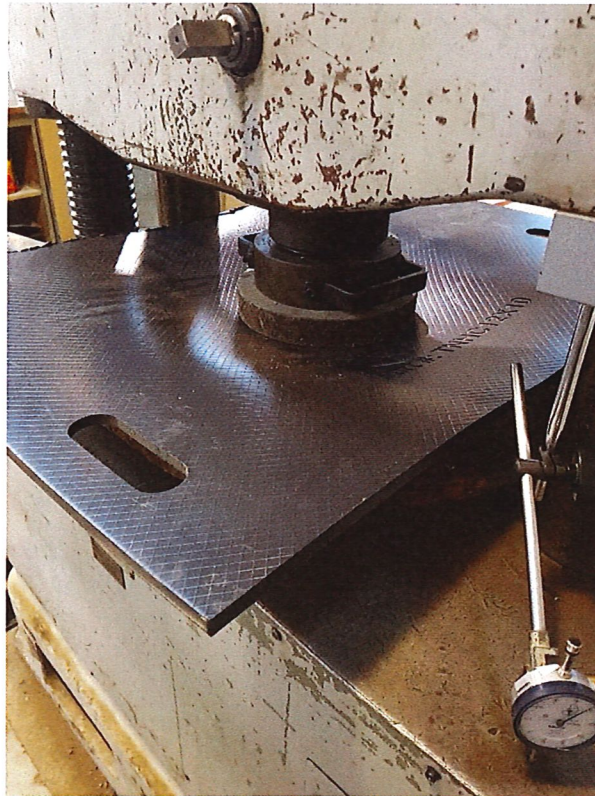
Figure 2 - 3kN Load Applied

| Applied Load (kN) | Applied Load (kg) | Figure number for photo at load (refer to pages 2-4) | Deformation at Centre (mm) | Observations |
|---|---|--|---|--|
| 3 | 306 | 2 | 12.93 | |

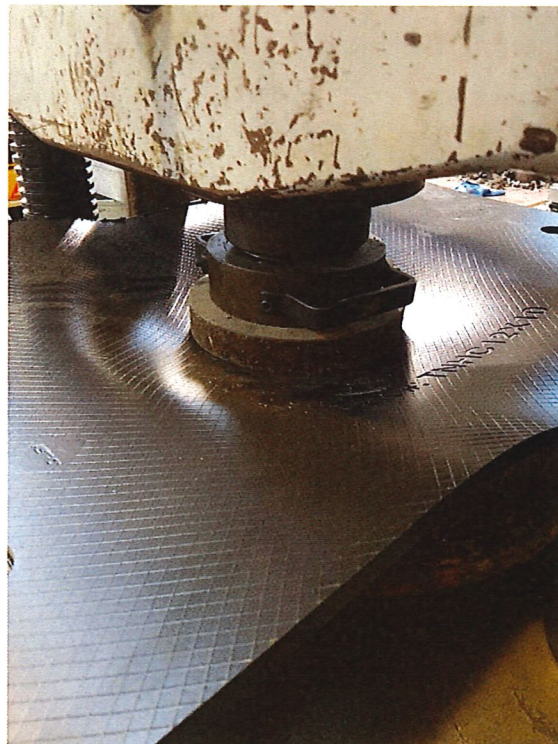
Figure 3 - 45kN Load applied

| Applied Load (kN) | Applied Load (kg) | Figure number for photo at load (refer to pages 2-4) | Deformation at Centre (mm) | Observations |
|---|---|--|---|--|
| 45 | 4587 | 3 | 54 | |

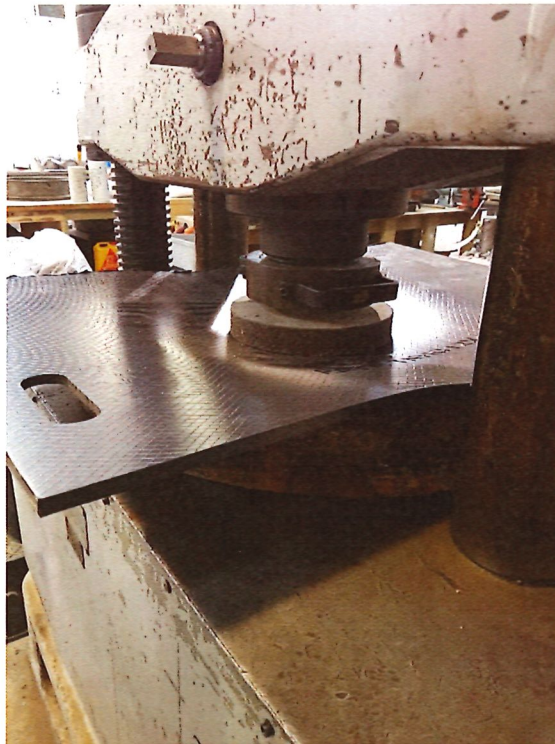
Figure 4 - After 45kN load is removed

| Applied Load (kN) | Applied Load (kg) | Figure number for photo at load (refer to pages 2-4) | Deformation at Centre (mm) | Observations |
|---|---|--|---|--|
| 0 (After 45kN load removed) | 0 | 4 | - | Substantial permanent set after 45kN load is removed. |
